Effective Road Pavement Reconstruction in the Fraser Coast Region QLD

A dissertation submitted by
Kaz Chapman-Vagg

in fulfilment of the requirements of
ENG4111 and 4112 Research Project
towards the degree of
Bachelor of Engineering (Honours) (Civil)
Submitted October, 2020

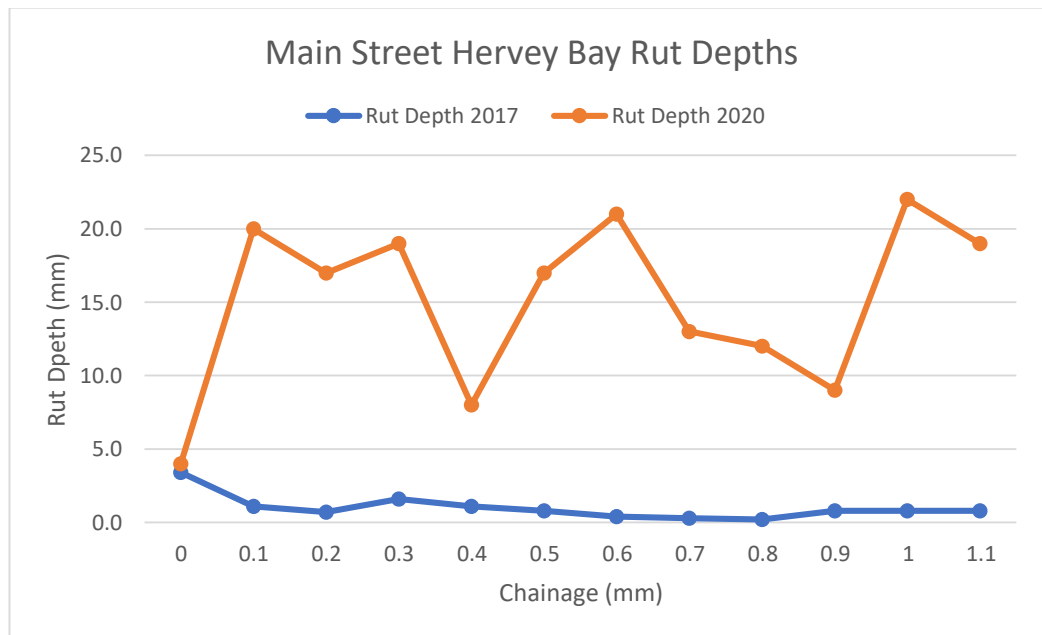
Figure 5.4: Main St Hervey Bay - Rut Depth

It can be seen from the above figure that the maximum rut depth identified at Main St in 2017 was 3mm. This does not correlate with the site inspection conducted which noted greater rut depths, indicating a greatly depreciated surface within the 3 year time frame. The locations of the 2017 rut depths were mapped and then manually measured with a straight edge and a tape measure for comparison. While some of these figures are large, there were other locations within the project extents which had exhibited more significant rutting and deflection.

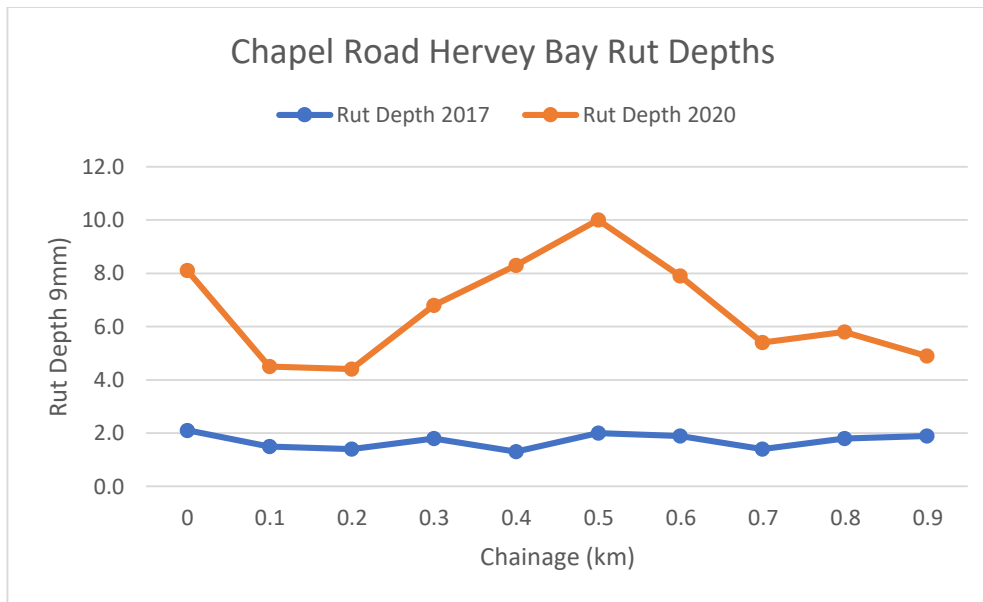
Figure 5.9: Chapel Road Hervey Bay - Rut Depths

It can be seen that in 2017, the maximum rut depth was just over 2.0mm at chainage 700 and the minimum rut depth was 1.9mm at chainage 400. According to APPA, the anticipated rate of rutting in flexible pavements is 1mm/year. In 2017, Chapel Road exhibited rut depths with a severity range of 0-5mm for 100% of the project. While Austroads does not consider this to be significant, the road was 2 years old and as such should not have exhibited any rut depths of greater than 2mm. This demonstrates a maximum rate of rutting of 2.67mm/year. By contrast, the manually measured rut depths indicate severity ranges of 0-5mm and 5-10mm of 44% and 66% respectively.

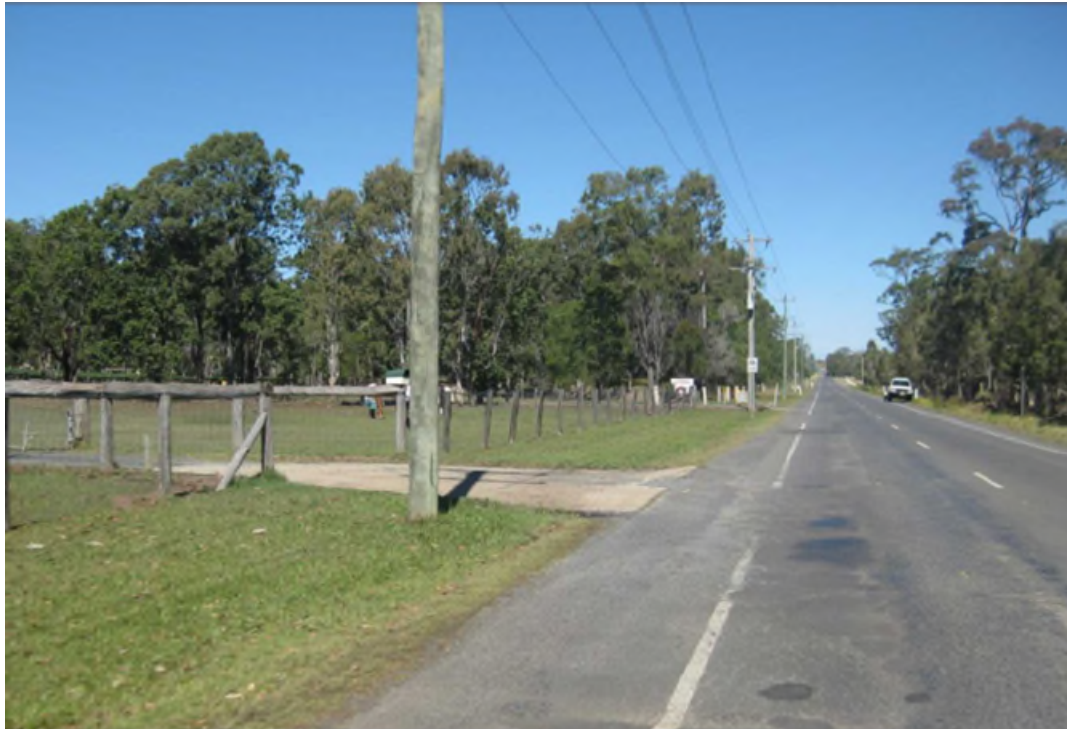
Figure 5.10: South Doolong Road Hervey Bay - Existing Formation

South Doolong Road Hervey Bay was identified as in need of reconstruction as part of Council's 2014/2015 capital works program. The road had seen significant growth in traffic due to new residential developments being constructed and as such the existing formation was not considered adequate and was exhibiting extensive deformation and patching, as shown in Figure 5.10. South Doolong Road is a collector road, connecting new residential developments and an established school with other suburbs in Hervey Bay.

The existing road structure consisted of a 9.0m wide road including shoulders with table drains either side, no kerb and channel or drainage structures. In 2014, FCRC commissioned a geotechnical investigation to determine the underlying geological conditions of the road as well as to analyse the existing pavement structure. A total of 6 bore holes were drilled with soaked CBR tests undertaken on subgrade material and DCP's taken in each hole. The investigation revealed a sandy clay subgrade of medium plasticity.

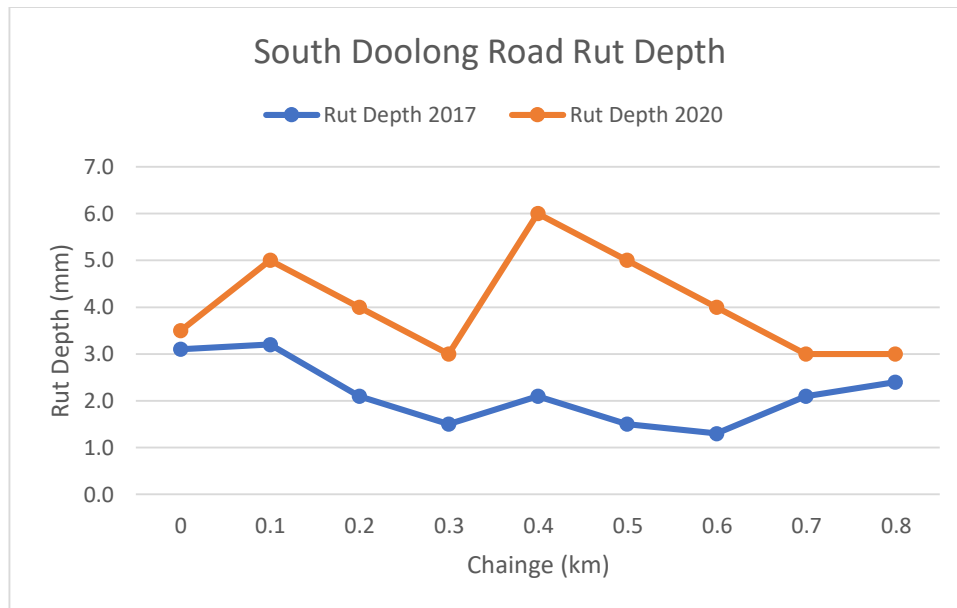
Figure: 5.12 South Doolong Road Hervey Bay - Rut Depth

As can be seen from the above figure, there has been an increase in rut depth since 2017, however it has been minimal. The maximum rut depth occurs at chainage 400m where a rut depth of 6mm was noted, suggesting a rutting rate of 1.2mm/year, slightly exceeding the acceptable 1mm/year benchmark. In 2017, South Doolong road had a rutting severity range of 0-5mm over 100% of the project. While in 2020, severity ranges of 0-5mm and 5-10mm were 89% and 11% respectively. Since Austroads does not consider rut depths less than 10mm to be significant, it can be seen the pavement is performing well for its age.

Since the extent of the defects at South Doolong Road is limited to the surface, it can be deduced that the C170 seal has been insufficient for the much higher than expected traffic volumes. If a PMB binder were used in lieu of the C170 and the seal designed for the correct amount of traffic, then the surface would have greater resistance the high stresses which it is subject to.

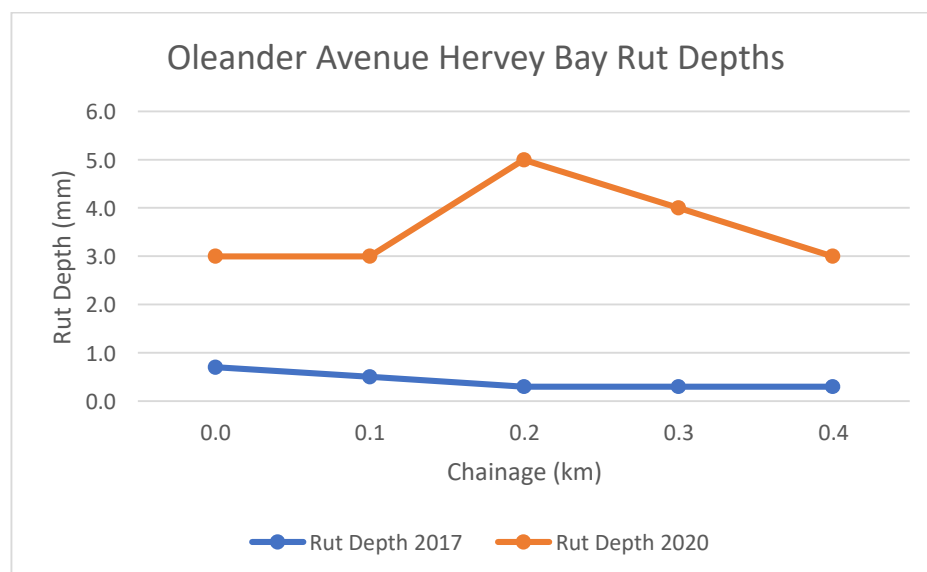
Figure 5.16: Oleander Avenue Hervey Bay - Rut Depths

It can be seen in Figure 5.16 that the rut depths observed at Oleander Avenue, in both 2017 and 2020, exhibited a severity range of 0-5mm for 100% of the project, indicating a well performing pavement. In fact, the average rate of rutting is less than the acceptable 1mm/year as suggested by AAPA while Oleander Avenue is demonstrating a maximum rate of rutting of 1.5m/year.

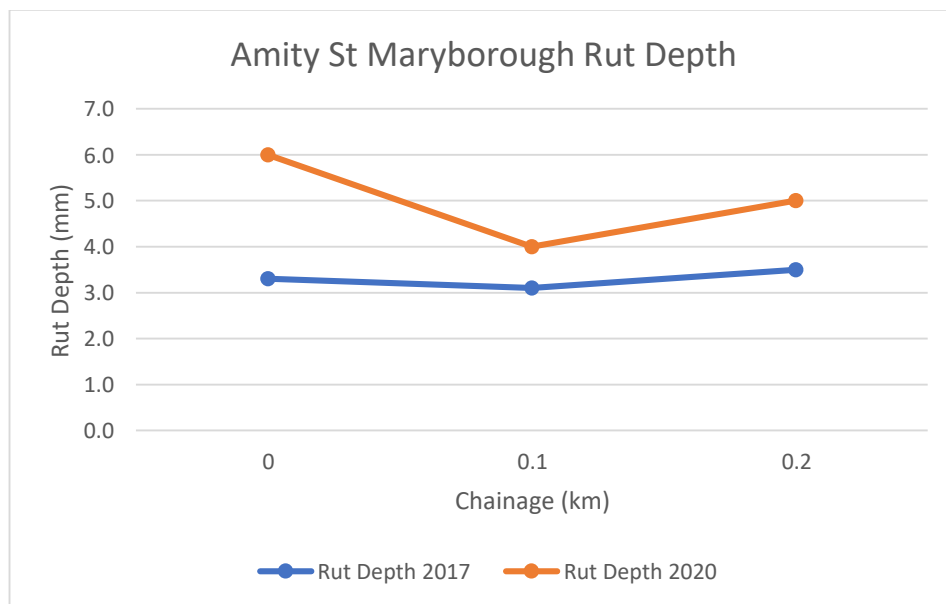
Figure 5.18: Amity Street Maryborough – Rut Depths

At the time of the 2017 AARB survey, Amity St Maryborough was 3 years old and had exhibited minimal signs of rutting or deformation. The condition data suggests that the maximum rut depth in 2017 was 3.5mm, indicating a well performing pavement. In fact, 100% of the roads measured rut depths had a severity of 0-5mm, which is regarded as largely

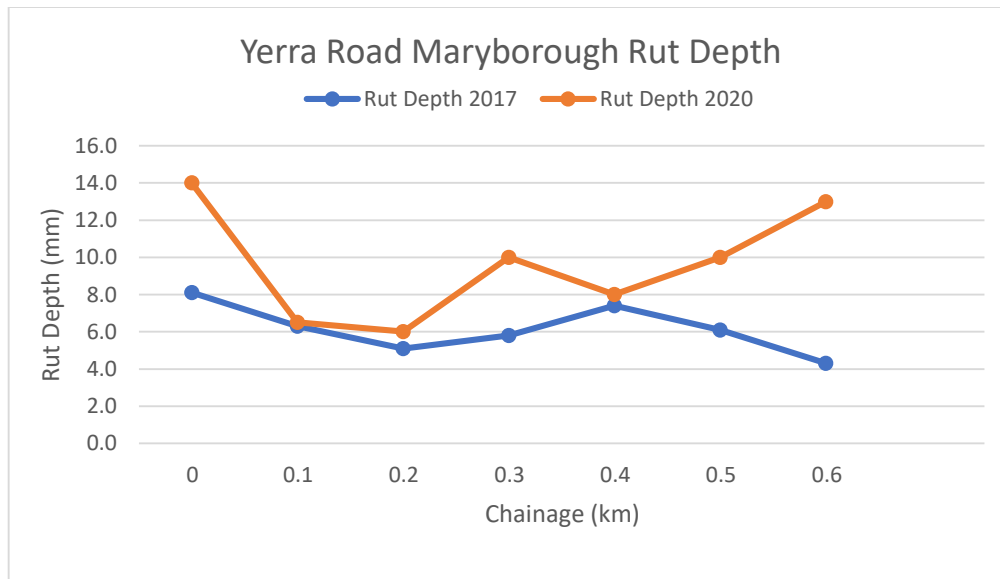
Figure 5.21: Yerra Road Maryborough – Rut Depths

At the time of the 2017 AARB survey, the road formation was 2 years old and had exhibited significant rutting for its age. This suggests serious subgrade failures and indicates an inadequate pavement profile. Yerra road [2017] displayed rutting severity ranges of 0-5mm and 5-10mm for 25% and 72% respectively. While Austroad's does not consider rutting of less than 10mm to be significant, this extent of rutting is not to be expected on a 2 year old pavement. The extent of rutting in 2020 can be seen to have worsened and has severity ranges of 5-10mm and 10-15mm of 43% and 57% respectively. Yerra Road has demonstrated a maximum rate of rutting of 3mm/ year.

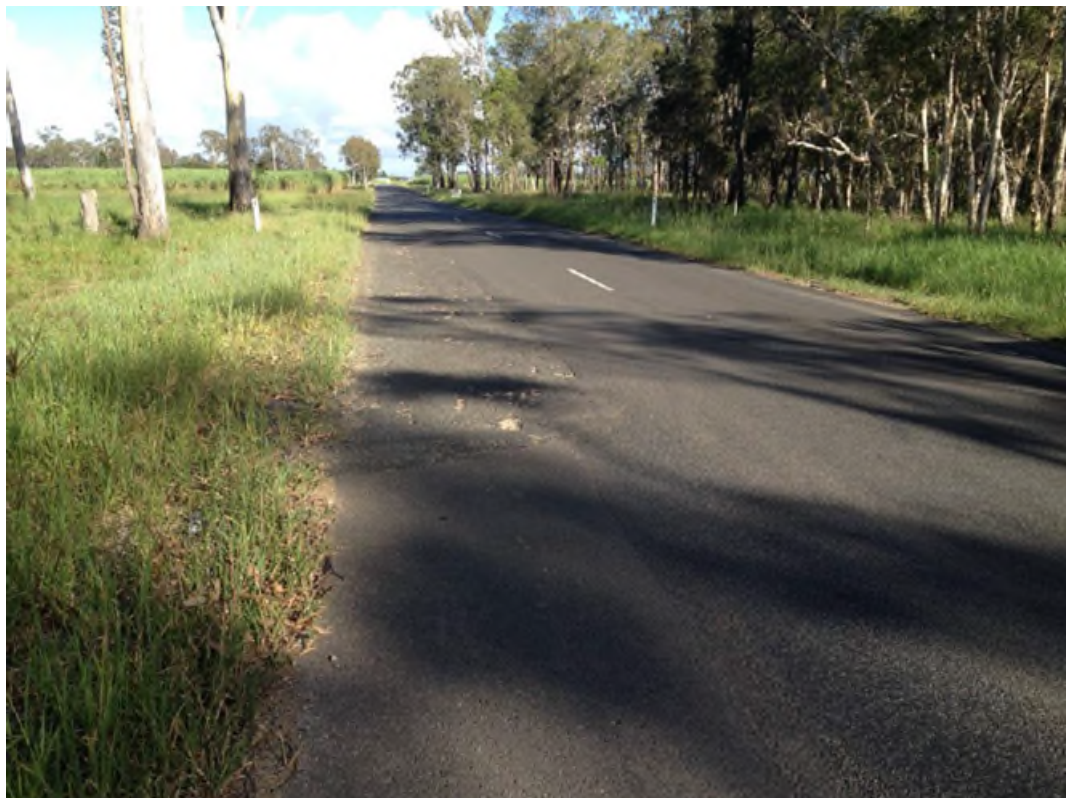
Figure 5.22: Beaver Rock Road Maryborough - Existing Formation

Beaver Rock Road Maryborough was identified for reconstruction in the 15/16 financial year due to the range of extensive pavement failures and poor shape of the existing road, as indicated in figure 5.22. Beaver Rock Road is a rural arterial road which provides access to rural properties and the lower Mary River. The existing road formation was a 6.5m, low lying road with minimal drainage causing extensive failures.

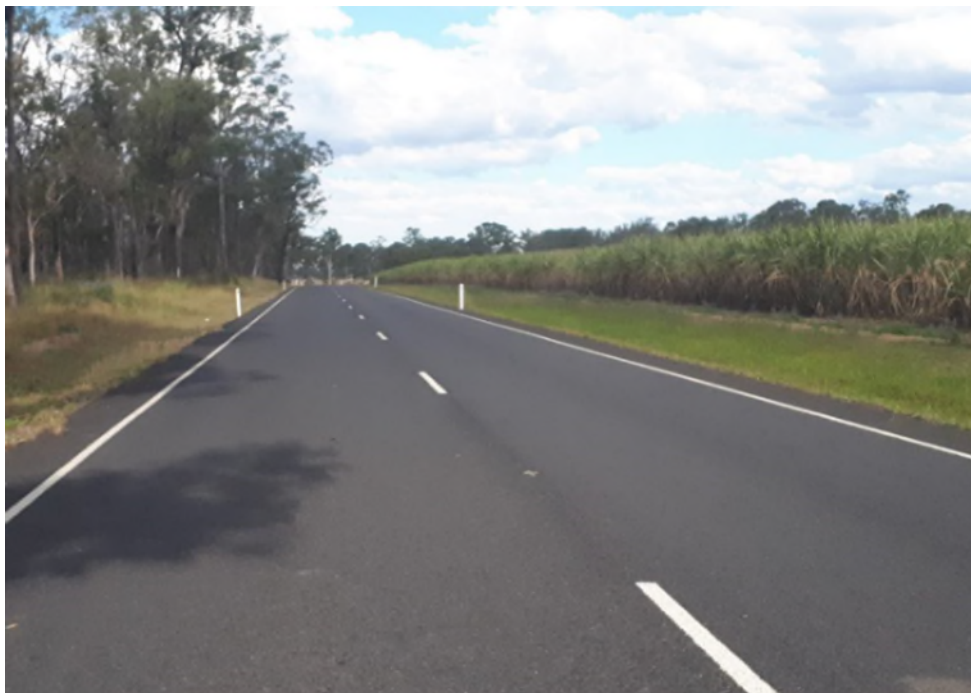
Figure 5.24: Beaver Rock Road Maryborough – Pavement Condition

A site visit to Beaver Rock Road Maryborough revealed that the constructed pavement appeared to be in fair condition with some minor flushing and rutting evident as shown in Figure 5.24.

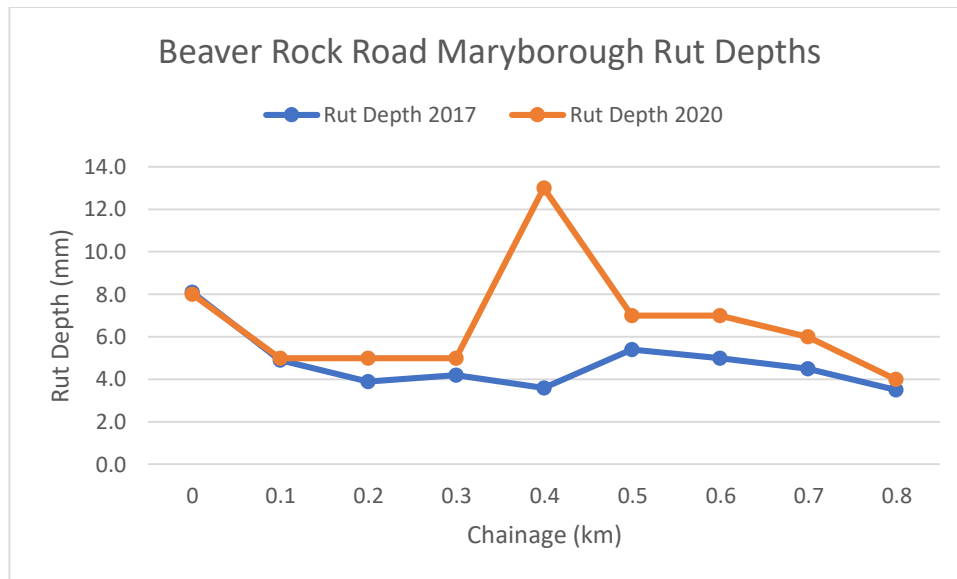
Figure 5.25: Beaver Rock Road Maryborough – Rut Depths

At the time of the 2017 AARB survey, the road formation was 1 year old and had exhibited significant rutting for its age with the maximum rut depth occurring at Chainage 0. This suggests subgrade or pavement failures. Beaver Rock road [2017] displayed rutting severity ranges of 0-5mm, 5-10mm and 10-15mm for 60%, 30% and 10% respectively. The extent of rutting in 2020 can be seen to have worsened, exhibiting severity ranges of 0-5mm, 5-10mm and 10-15mm for 44.5%, 44.5% and 11% respectively. Beaver Rock Road has demonstrated a rate of rutting of 3mm/year.

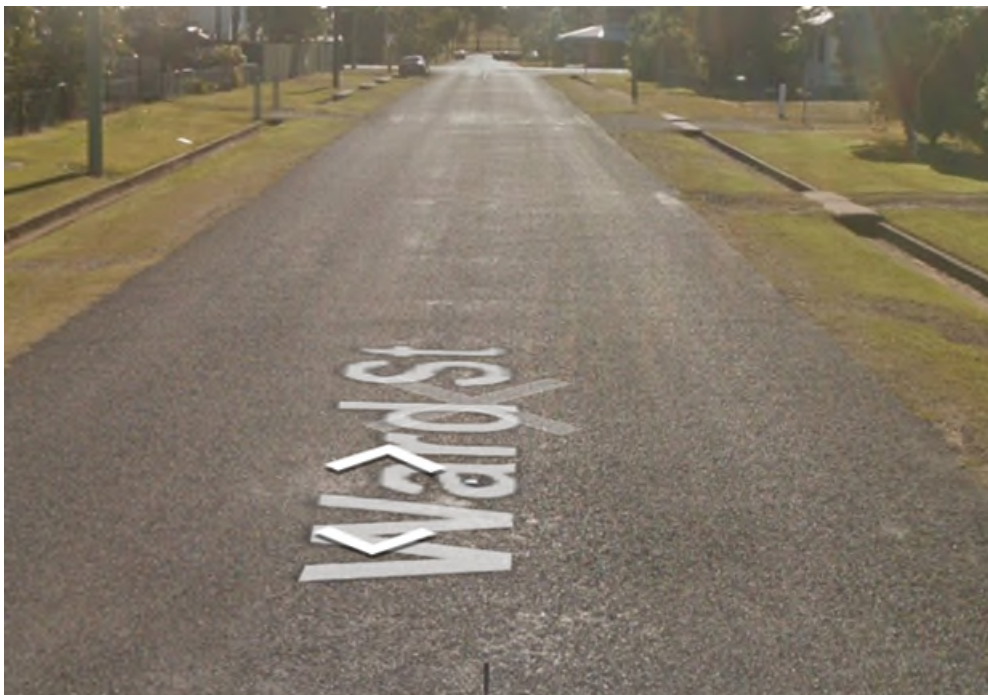
Figure 5.27: Ward Street Maryborough – Existing Formation (Google, 2020)

Ward Street Maryborough was identified for reconstruction as part of the FCRC's 2015/2016 financial year capital works programme. The existing road was 7m wide with unsealed shoulders and kerb and channel, as indicated in Figure 5.27. FCRC records do not contain photos of Ward St prior to reconstruction, however Google Street View was used to provide a look at the condition of the pavement. Ward Street is an access residential road in the road network hierarchy.

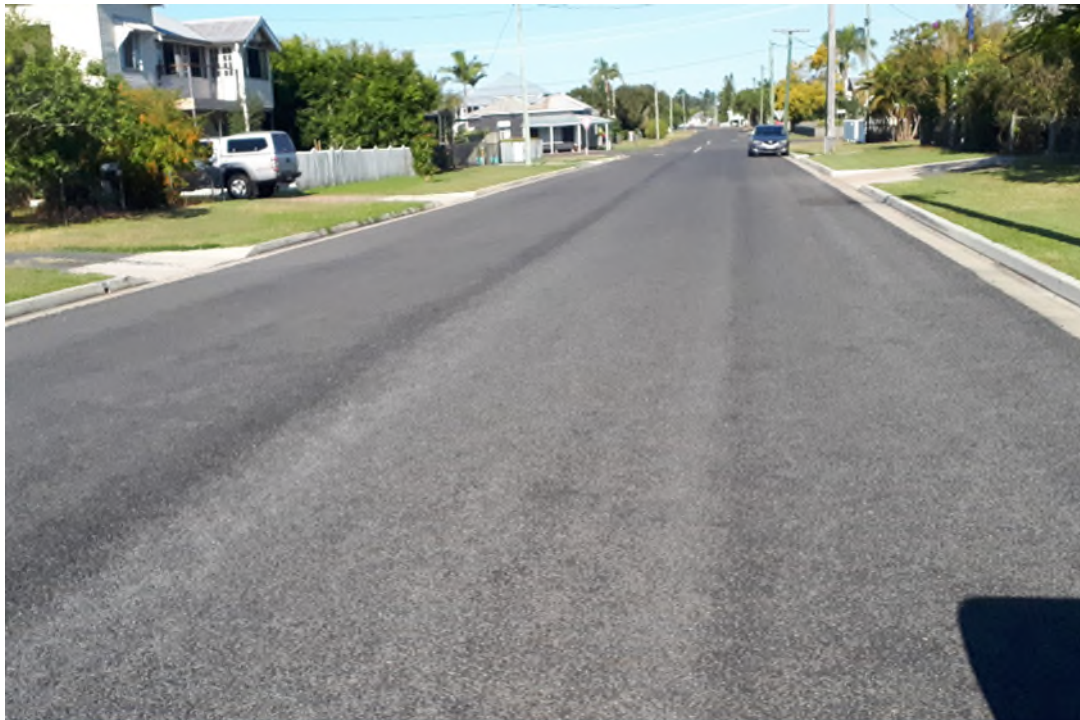
Figure 5.29: Ward Street Maryborough – Pavement Condition

A site investigation to Ward St Maryborough revealed that the pavement appeared to be in good condition, with no deformation or evidence of distress, as indicated in Figure 5.29. The seal was even found to be in good condition with minimal surface distress as displayed on most other pavements.

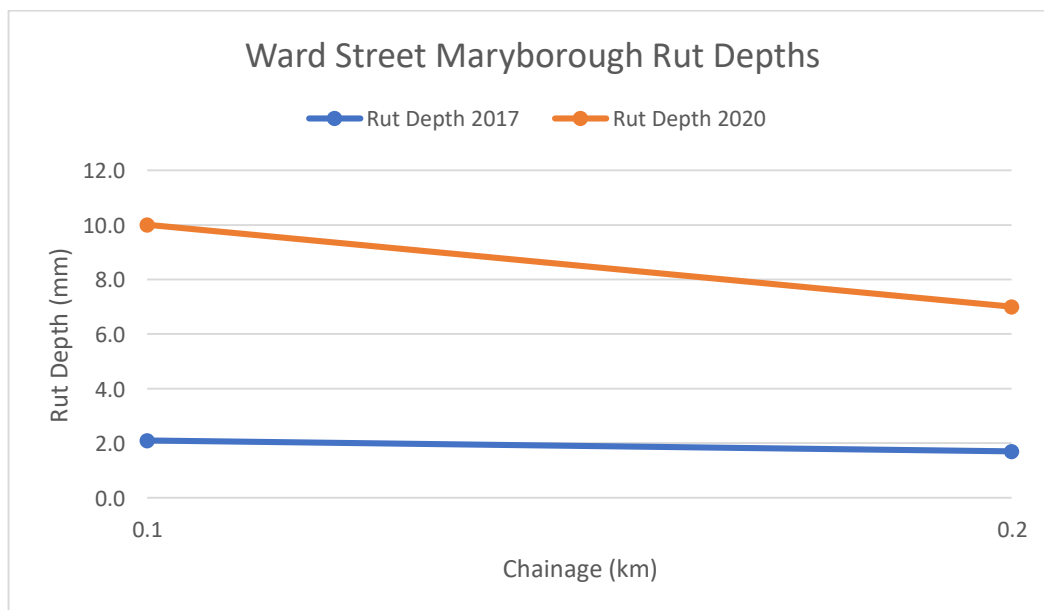
Figure 5.30: Ward Street Maryborough Rut Depths

At the time of the 2017 survey, Ward St was 12 months old and had demonstrated a maximum rut depth of 2.0 mm where 100% of measured depths were within the severity range of 0-5mm. Meanwhile, the 2020 the maximum rut depth has increased to 10mm where the severity ranges are 0-5mm and 5-10mm for 50% each. Ward St has demonstrated a maximum rate of rutting of 2.67mm/year. Overall, the pavement at Ward St appears to be performing well for its age and with scheduled maintenance should easily reach its service life. Accurate traffic count data is not available for Ward St Maryborough.

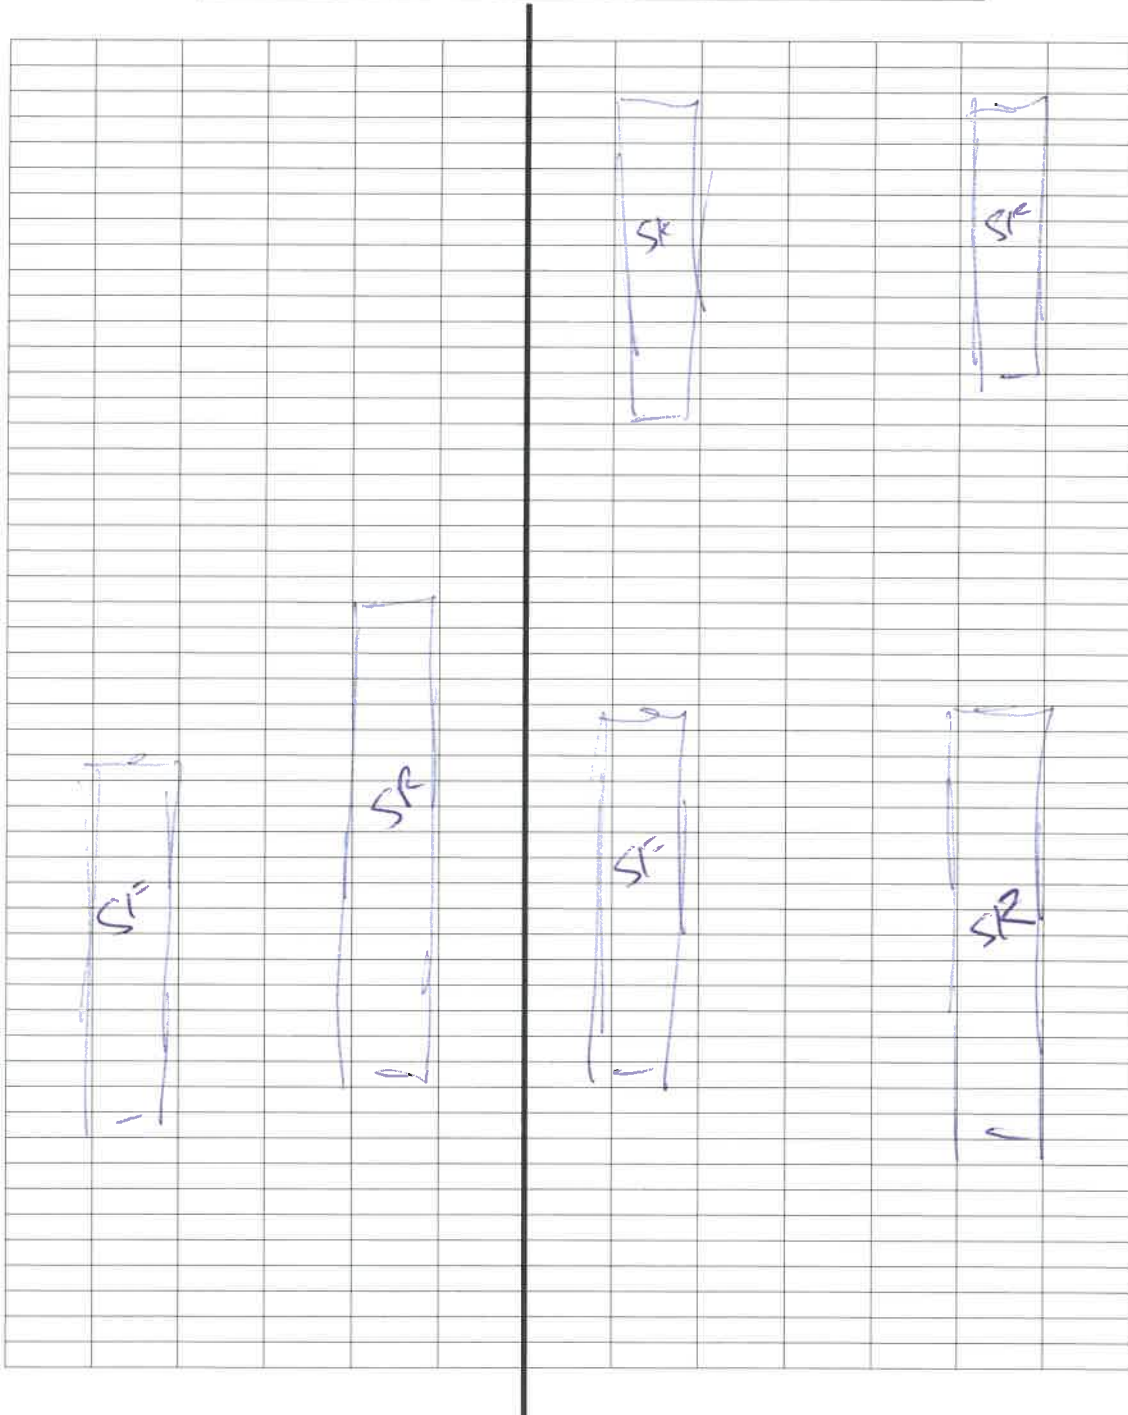
CH 800

Site Name:	OLEANDER AVE HERVEY BAY	Year Constructed	2016
Weather Conditions:	FINE	Time:	7am
Site Record	<p>Traffic Conditions (Vehicle Types, volumes etc.):</p> <p>* HIGH TRAFFIC VOLUME - MOSTLY CARS</p> <p>* LOW HEAVY VEHICLES.</p>		
Identified Defects	<p>* NO IDENTIFIED DEFECTS</p> <p>* VERY SHALLOW RUT DEPTHS.</p>		
Overall Pavement Condition (1=best)	<p>1...✓.....3.....5.....7.....10</p>		
Signature

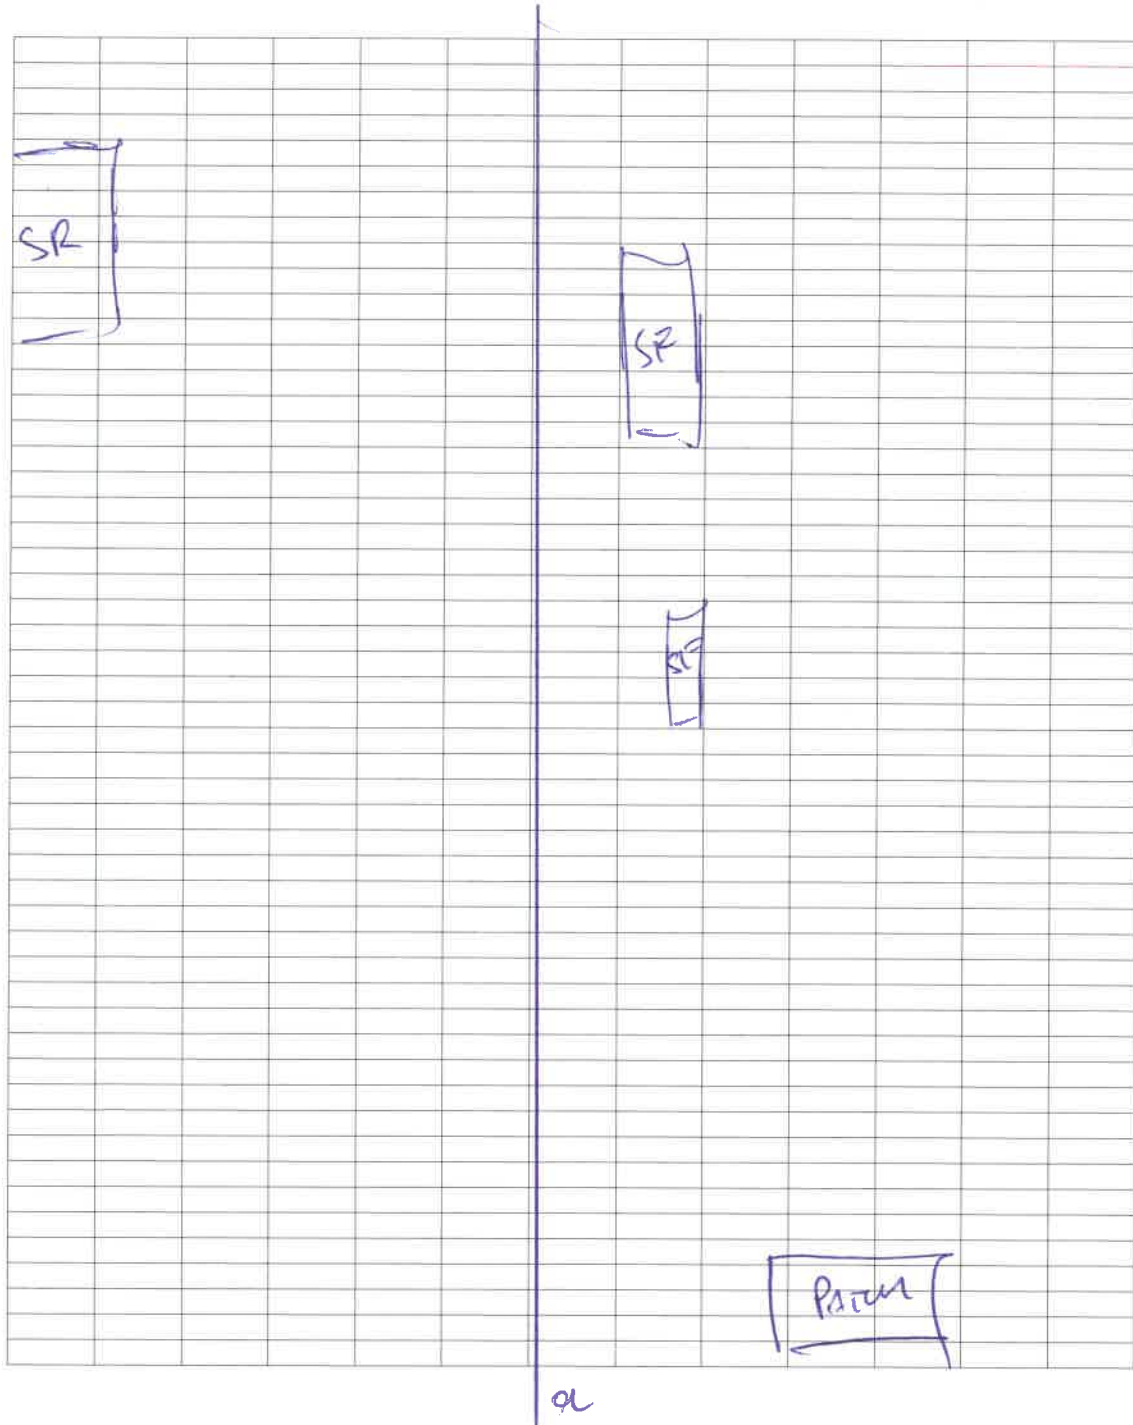
Site Name:	YERRA ROAD	Year Constructed	2015
Weather Conditions:	FINE	Time:	1pm
Site Record	<p>Traffic Conditions (Vehicle Types, volumes etc.):</p> <ul style="list-style-type: none"> * HIGH HEAVY VEHICLES * CANE TRUCKS * LOW TRAFFIC 		
Identified Defects	<ul style="list-style-type: none"> * RUTTING * DEFORMATION * FLOWING 		
Overall Pavement Condition (1=best)	<p>1.....3.....5.....<u>7</u>.....10</p>		
Signature

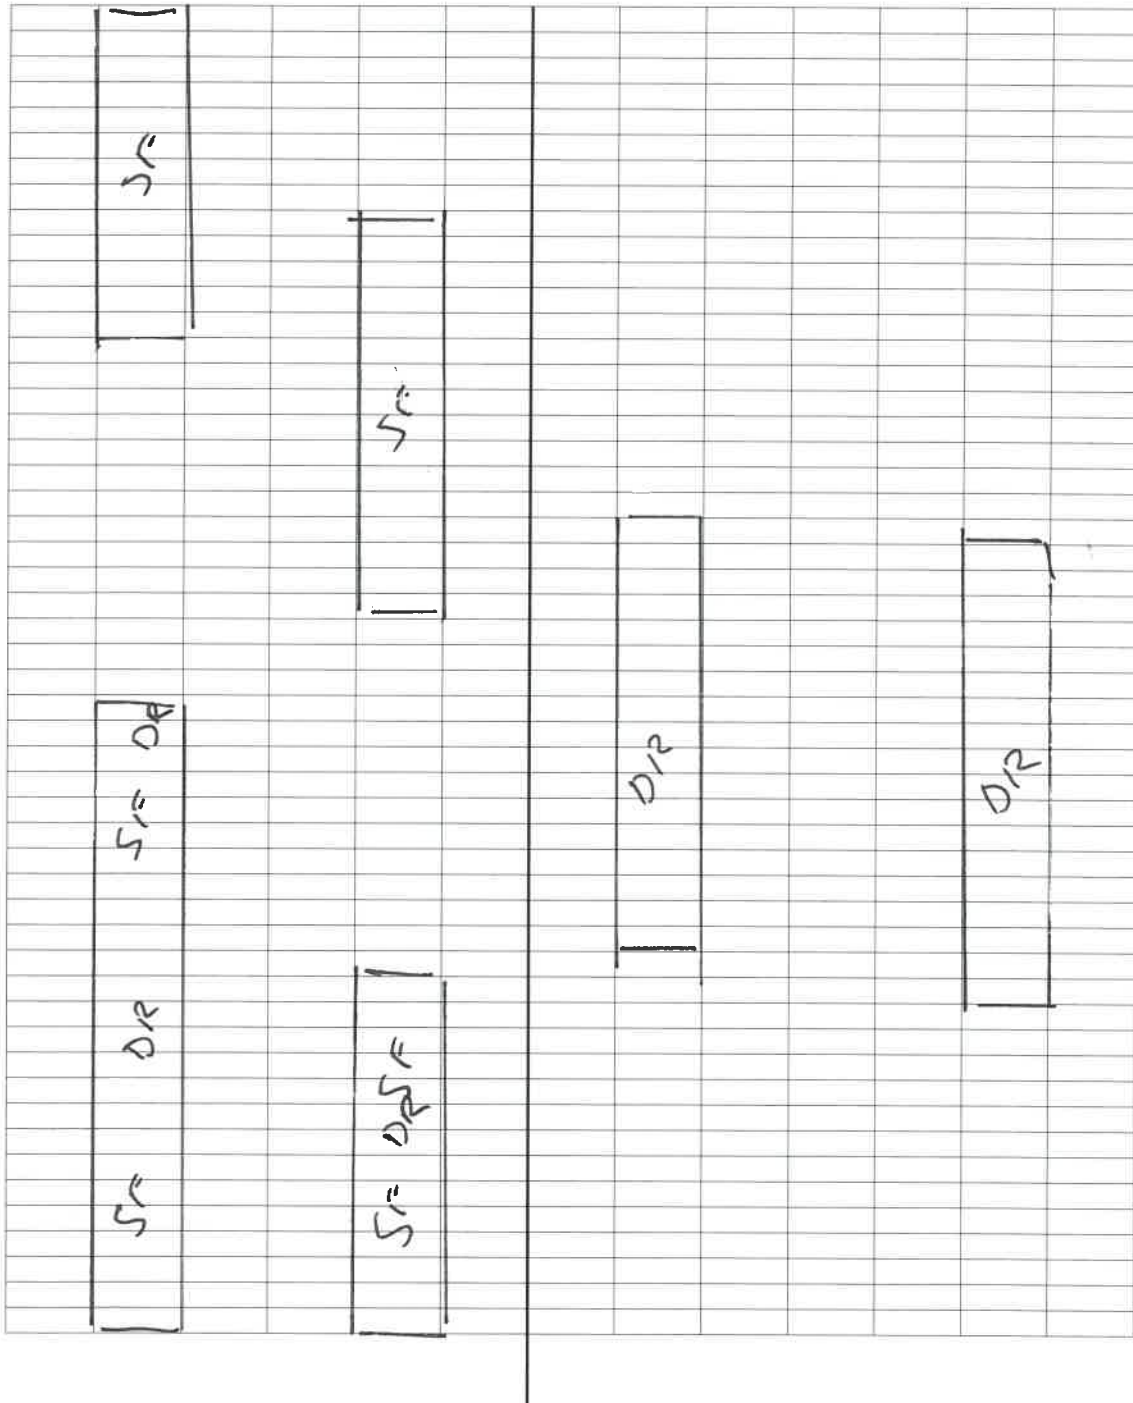
Site Name:	BEAVER ROCK ROAD	Year Constructed	2016
Weather Conditions:		Time:	2pm
Site Record	<p>Traffic Conditions (Vehicle Types, volumes etc.):</p> <ul style="list-style-type: none"> * CANE TRUCKS * LOW TRAFFIC 		
Identified Defects	<ul style="list-style-type: none"> * MINOR FLUSHING. * RUTTING * ISOLATED DEFORMATION 		
Overall Pavement Condition (1=best)	<p>1.....3.....5.....".....7.....10</p>		
Signature	 <hr style="width: 50%; margin: 0 auto;"/> Inspector		<u>10/08/20</u> Date

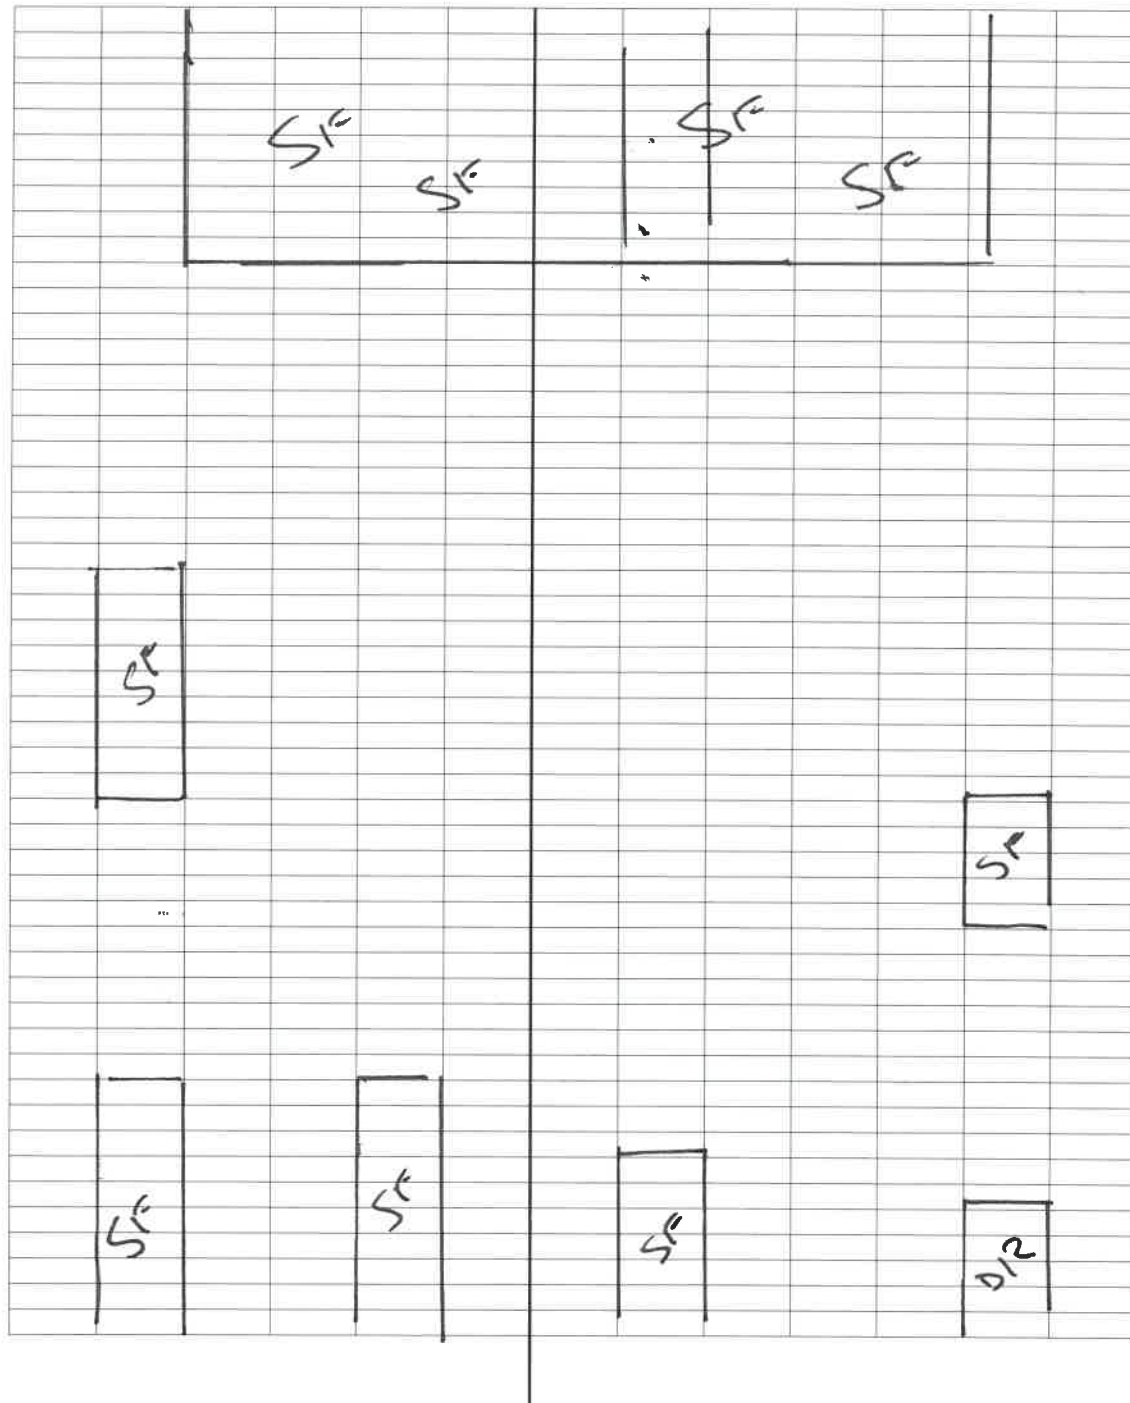
Site Name:	WARD ST MARYBOROUGH	Year Constructed	
Weather Conditions:	FINE	Time:	2.50 pm
Site Record	<p>Traffic Conditions (Vehicle Types, volumes etc.):</p> <p>✓ NO PASSING TRAFFIC AT TIME OF INSPECTION</p> <p>• LIKELY ONLY RESIDENTIAL TRAFFIC</p>		
Identified Defects	<p>* NO DEFECTS NOTED</p> <p>• PAVEMENT APPEARS TO BE IN VERY GOOD CONDITION.</p>		
Overall Pavement Condition (1=best)	<p>1.....✓.....3.....5.....7.....10</p>		
Signature
